## Coal Mine Fatal Accident 2005-17

| Operator: | Drummond Company, Inc. |
| Mine: | Shoal Creek Mine |
| Accident Date: | August 10, 2005 |

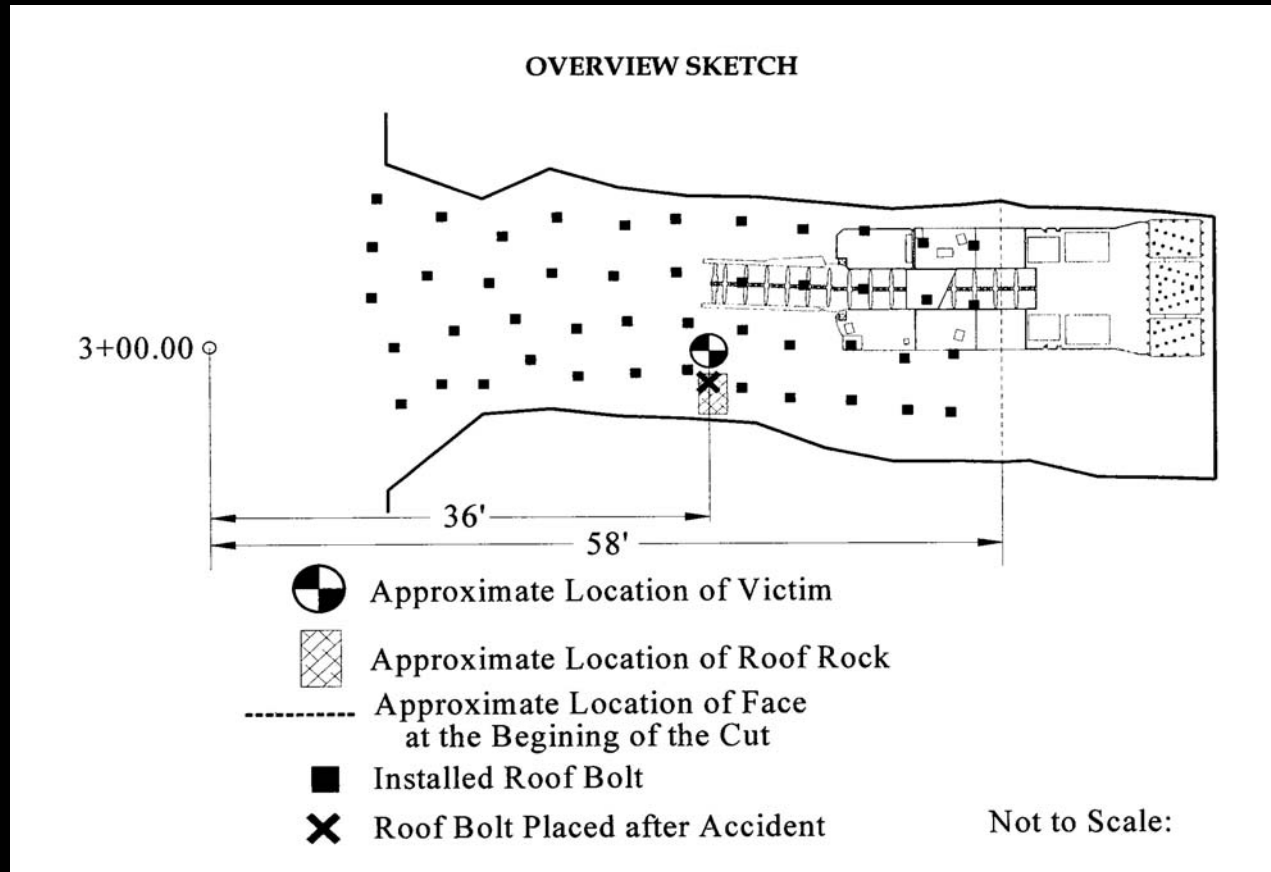
At ~ 8:00 p.m. on Thursday, August 10, a 54-year old continuous miner operator was fatally injured in a roof fall. The victim was struck by a 30" x 30" x 6" piece of roof rock that fell from between the rib and roof bolts. He was operating the continuous mining machine via radio remote control, while standing along the right rib, when the accident occurred. The victim died of his injuries on November 15, 2005. He had 1 year, 13 weeks experience in this occupation.

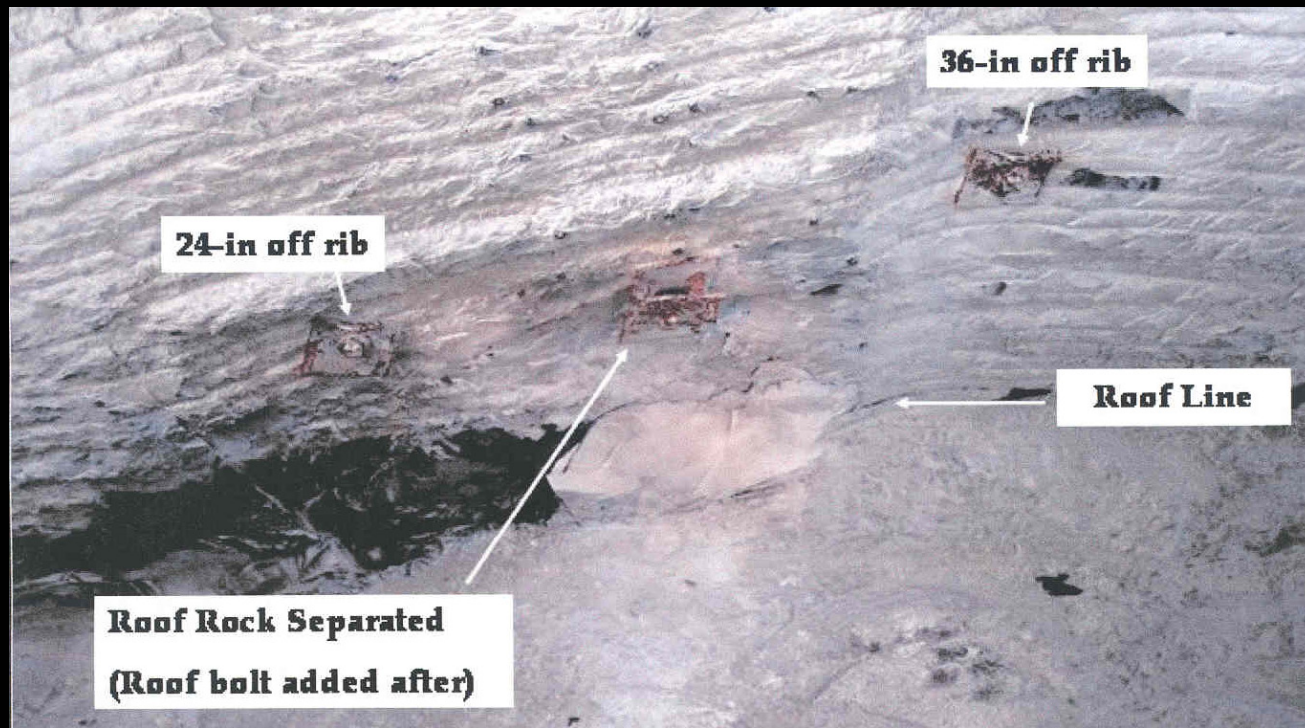
Causal Factor: A localized geologic discontinuity, exposed during mining, was not recognized and adequate precautions to eliminate the hazard were not taken.

Corrective Action: The mine operator installed additional support in the area of the fall. Safety awareness discussions have been conducted on the importance of workplace examinations, emphasizing roof, rib, and floor conditions.
